CTION OF A 12-YEAR-OLD GLUED-LAMINATED

STRINGER BRIDGE WITH NAILED-LAMINATED DECK--

DECAY HAZARD ASPECTS

Report to Division of Engineering,
Forest Service

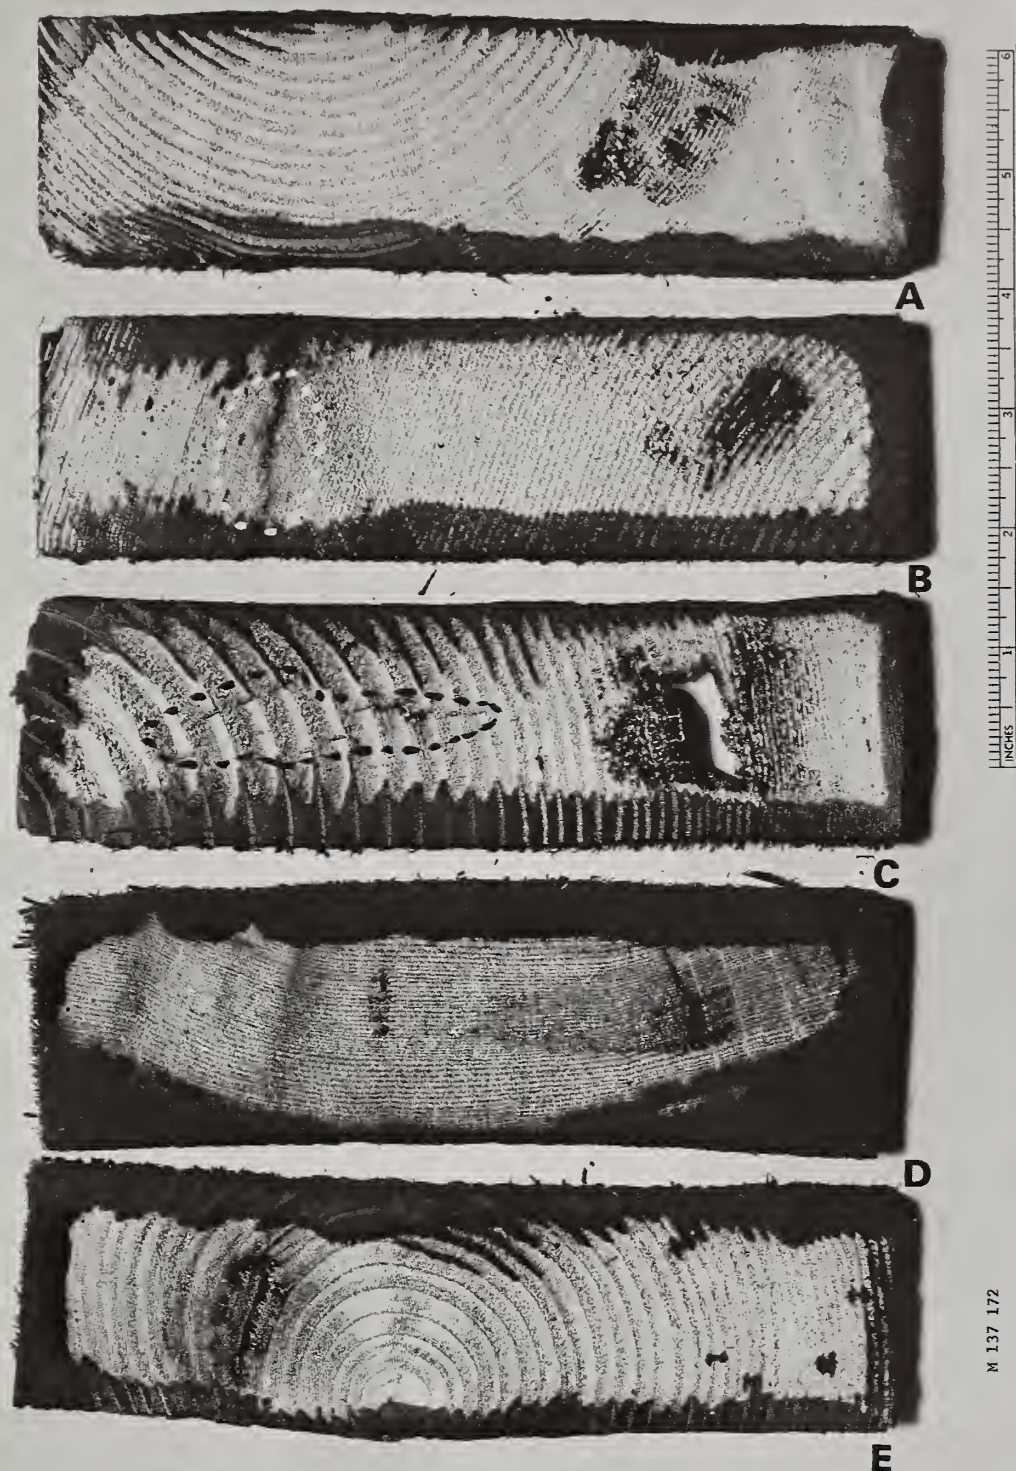
Figure 12.--Each of the five deck samples show at least one very definite area of advanced decay and samples B and C each show two areas of decay. Erratic preservative penetration is also apparent in this set of samples. The amount and severity of the decay shown here would account for a very severe loss of strength that is highly significant in view of the wide stringer spacings involved (long deck spans). Of equal importance is the fact that decayed deck elements do not occur in a truly random pattern of individual boards over the bridge length but instead tend to occur as groups of decayed boards alternating with groups of relatively sound boards having much less decay. (M 137 172)

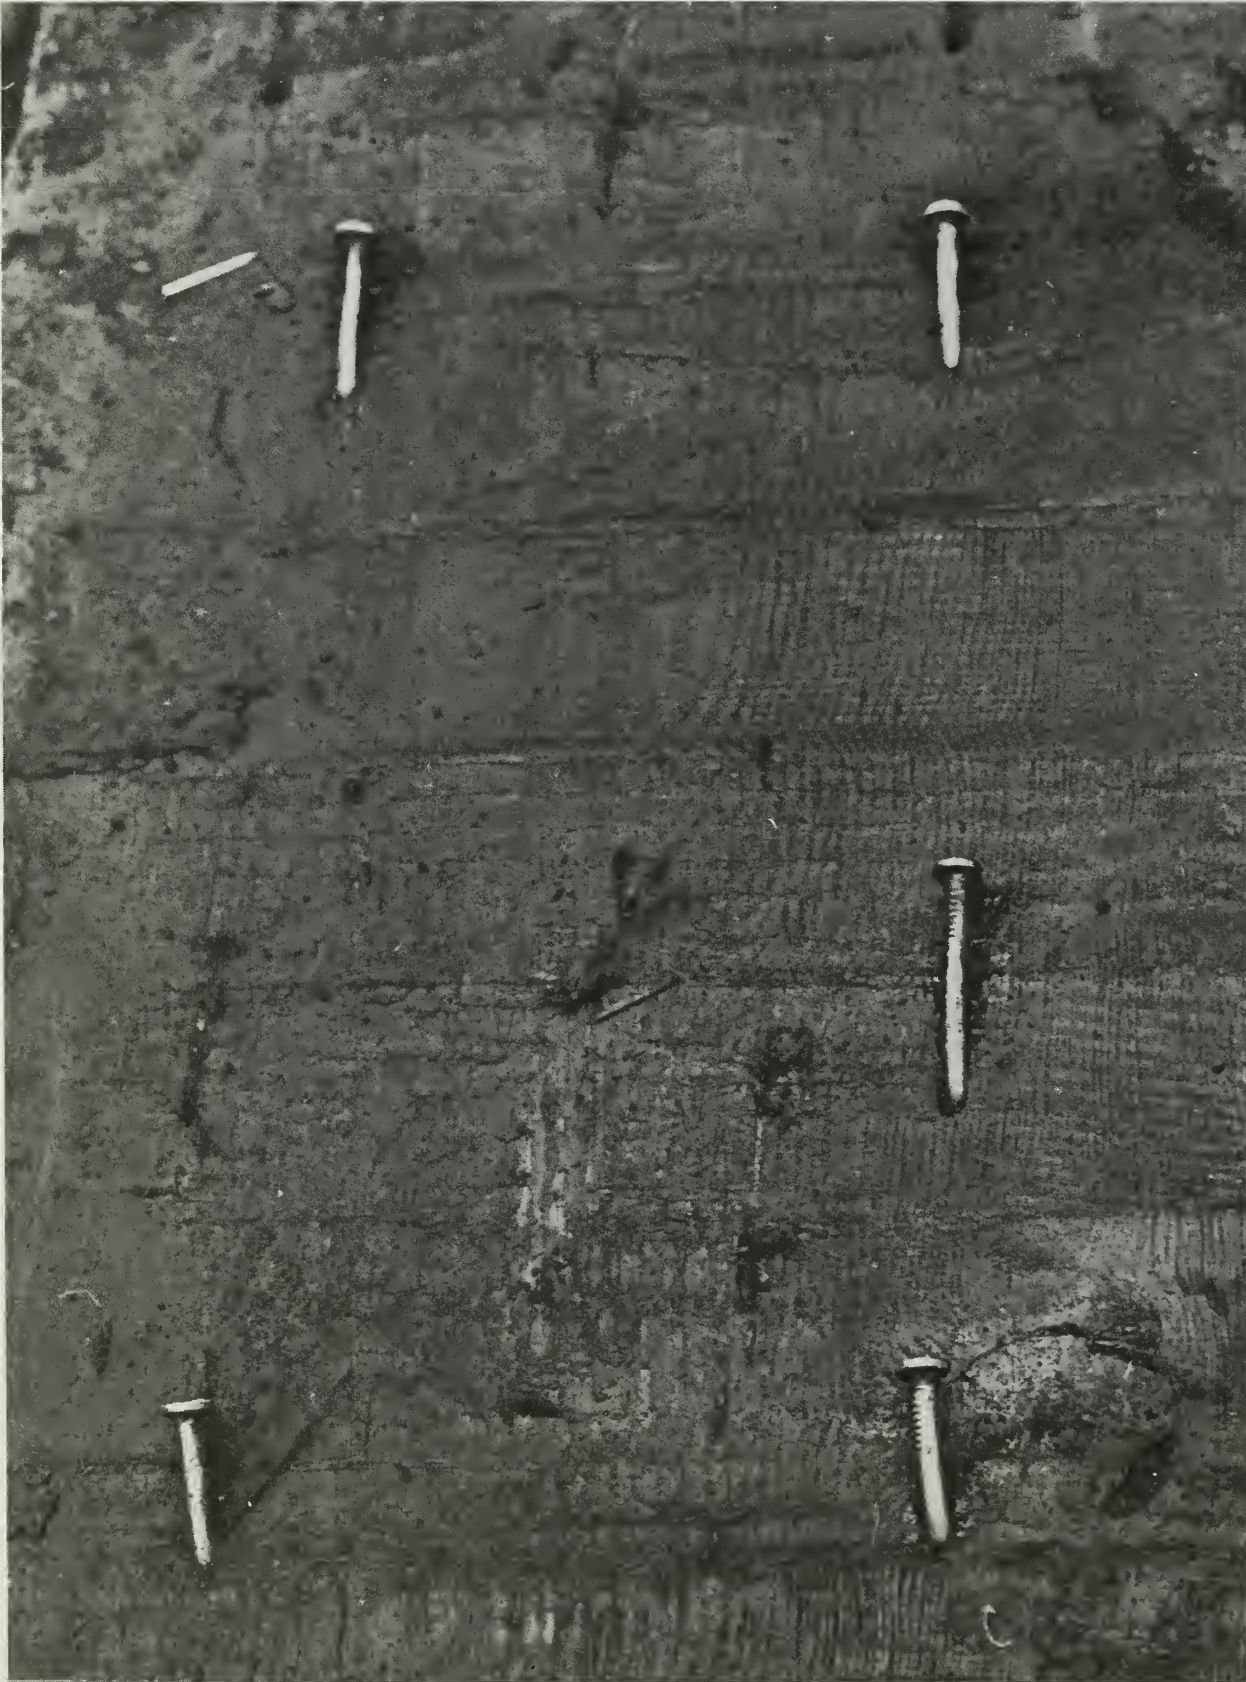
Stringer tops showed corresponding wear, but were characteristically scalloped in a pattern corresponding to the rounded lower edges of the adjacent deck planks (figs. 9 and 13). No accurate measurement of material loss was obtained on the stringer tops, but in some areas most of the preservative-penetrated wood had been removed. This probably represented a loss of surface material from 1/16 to 3/16 inch in depth.

Figure 13.--This upper surface area of the center stringer shows inplace toenails which did not hold the decking in place on the stringer as evidenced from the wear pattern along the top of the stringer. This usually resulted from either toenail hole enlargement in the lower edge of the decking or actual splitting of the decking to release the decking to movement under traffic loading.

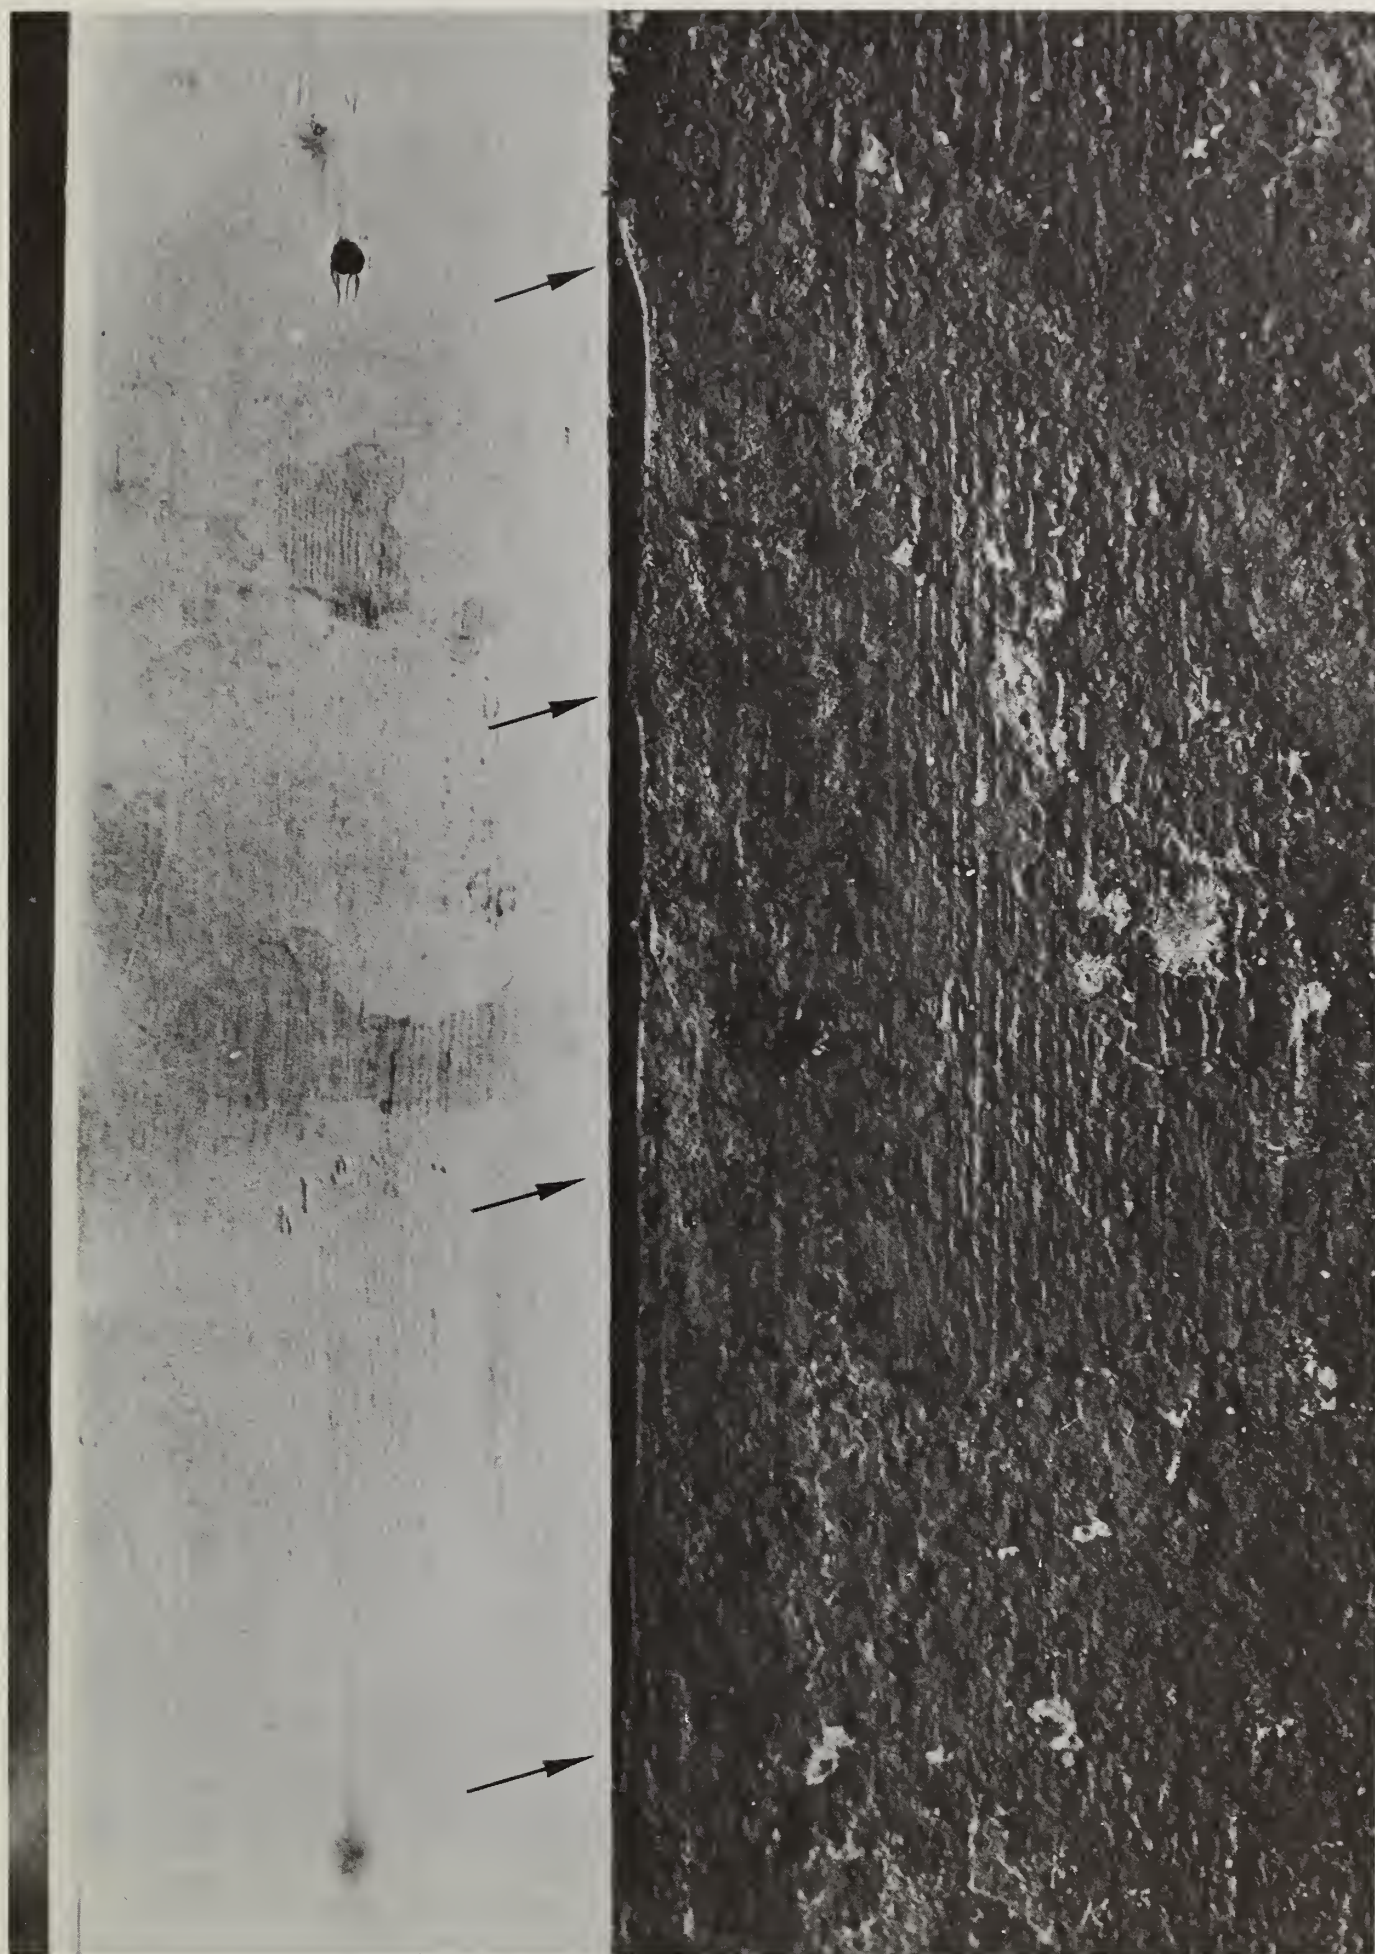
This pounding and the associated decking movements were made more serious by the presence of mud and sand accumulations between the deck boards and along the top of the stringers. This material causes the decking movement and pounding contacts to be abrasive, with a resulting loss of the thin layer of preservative-treated wood from the lower edges of some deck boards. The bottoms of the deck boards in such areas were slightly rounded and worn to depths of 1/4 inch or slightly more, corresponding to the shape of the stringer cross section (fig. 14).

Figure 14.--The pattern of wear in a deck stringer member at a stringer contacting surface is shown by contrasting the worn area with a straight-edged, fresh 2- by 4-inch board held against the decking.

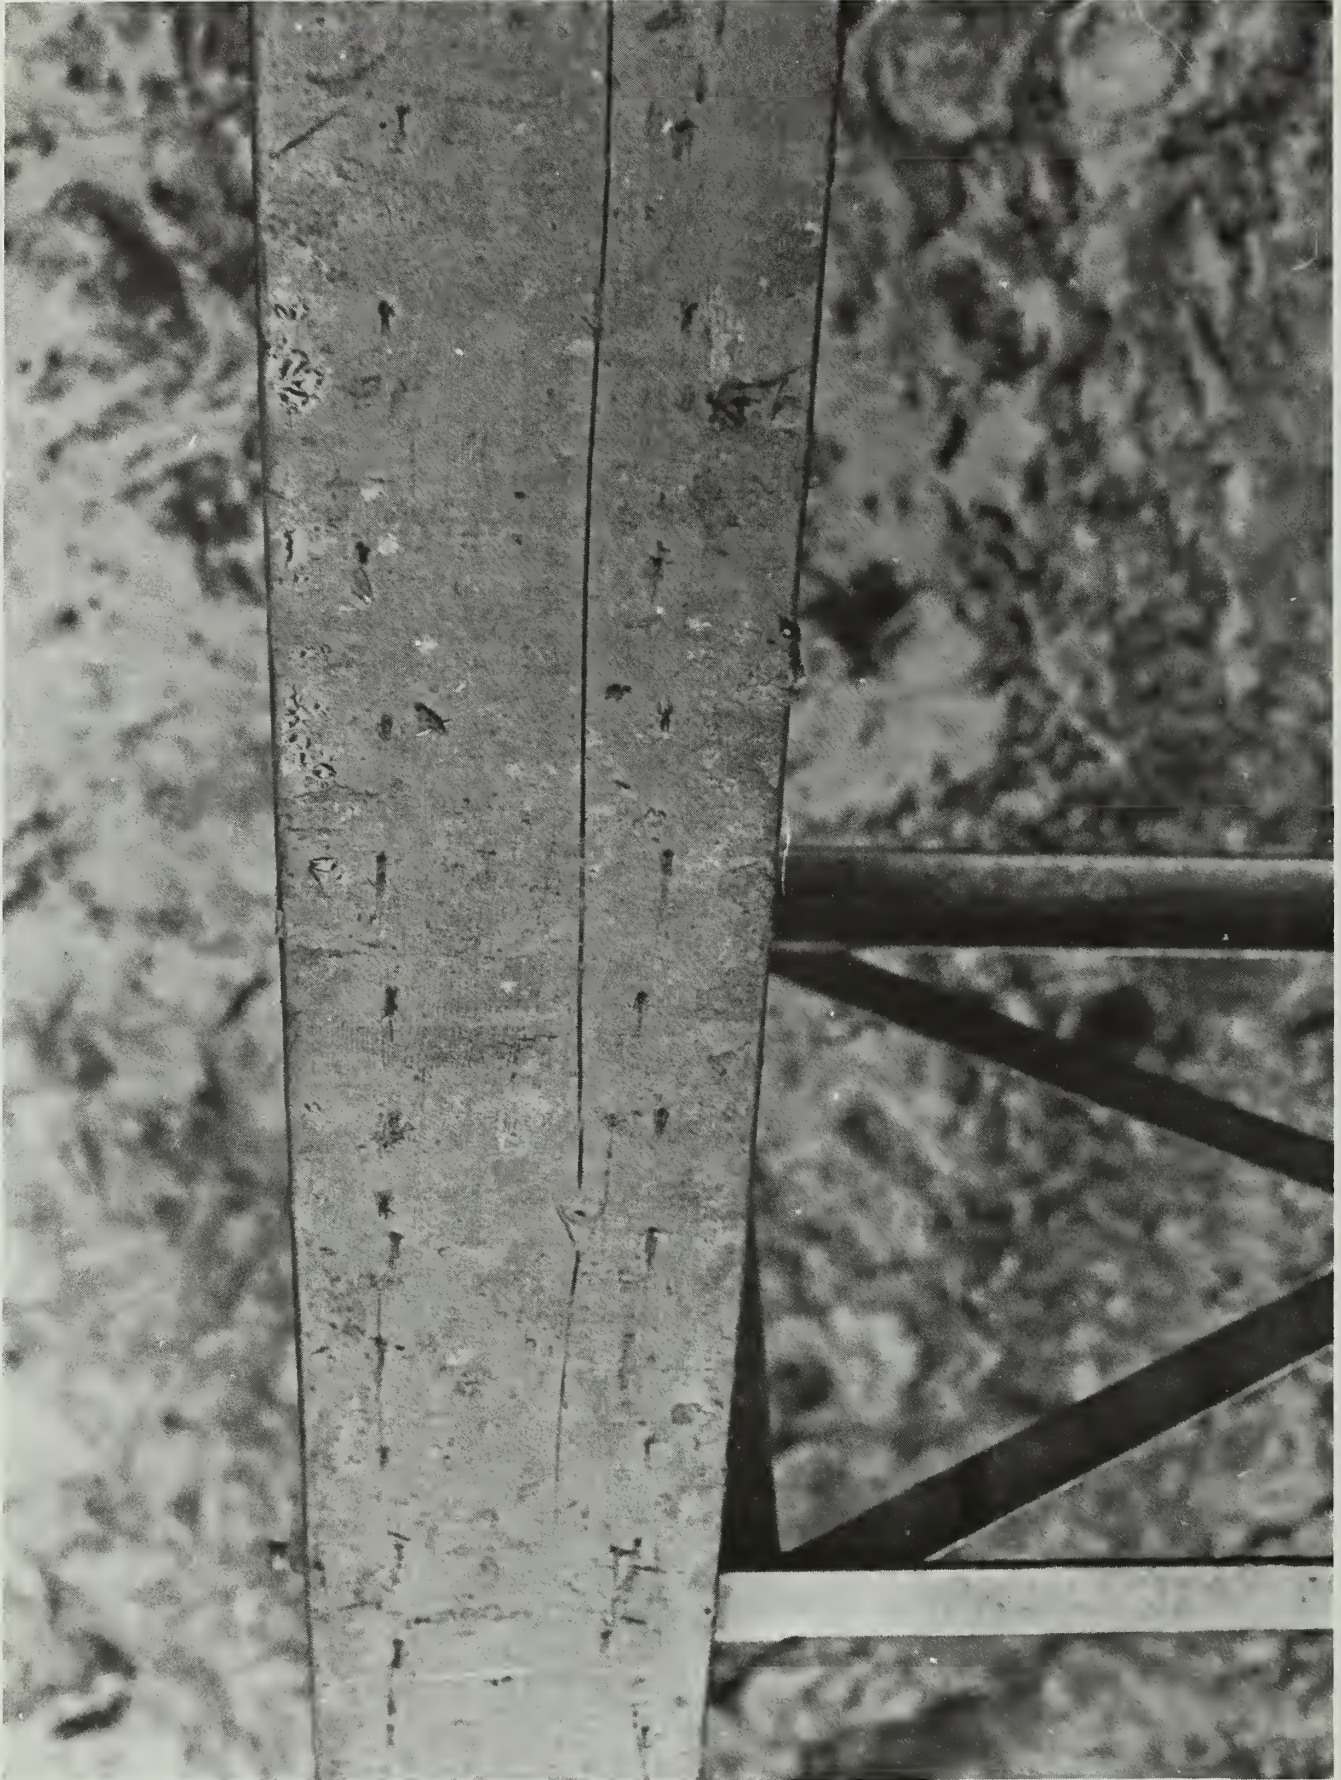
Figure 15.--A section of the upper surface of an outer stringer showing the toenail holes and a large seasoning check. Both the toenail holes and the large checks expose untreated wood to rain seepage and consequent moisture buildup that constitutes a significant decay hazard.

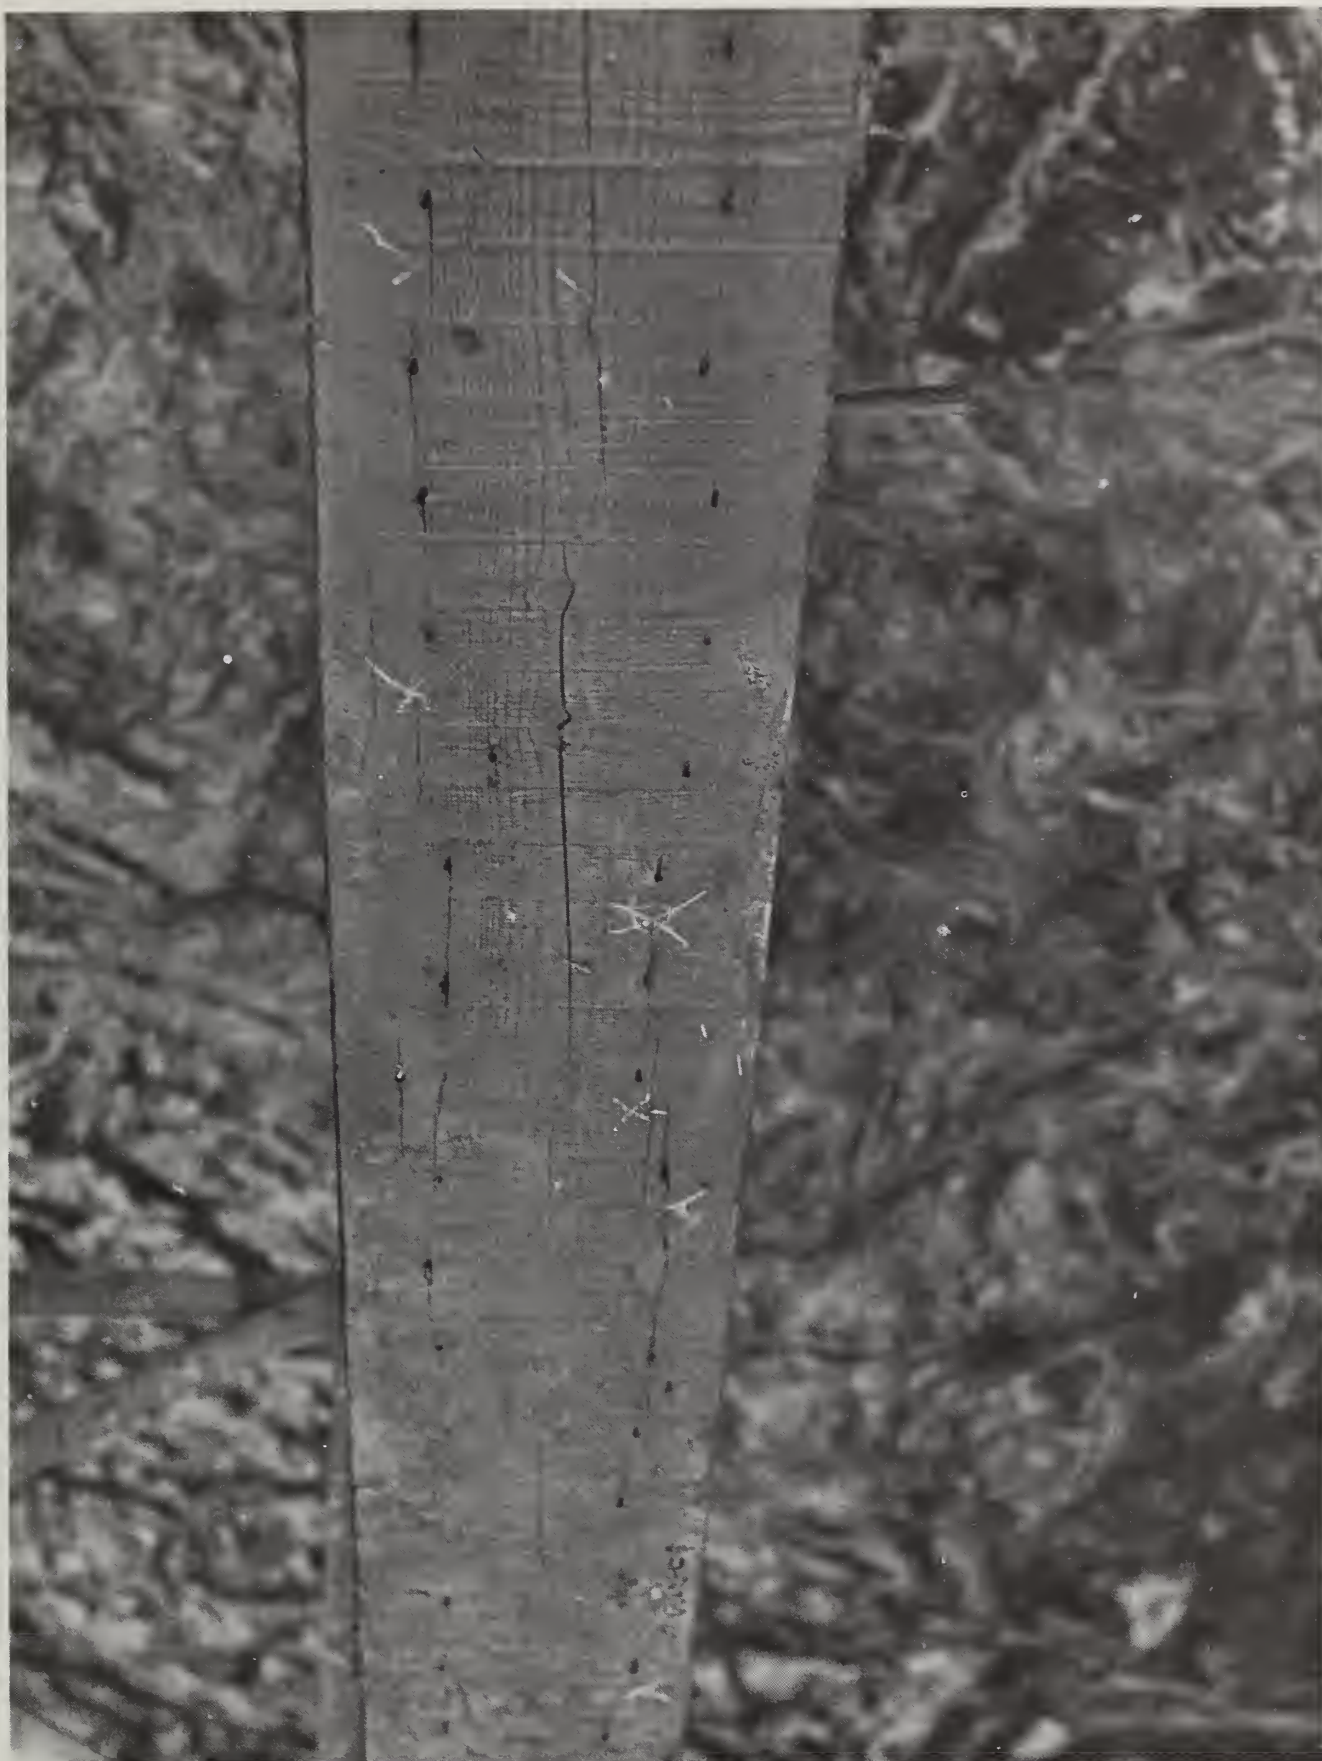
Longitudinal splitting and checking in the upper laminate was frequently observed in the stringer tops. Commonly, splitting occurred at toenail holes and less frequently checking was noted, independent of any nailing and essentially being large seasoning checks (figs. 15 and 16). In either case, such splits and checks far exceeded the depth of preservative penetration in the stringer tops as did the toenail penetrations. A very considerable variation in this regard appeared to be associated with the individual upper laminates of the stringers.

Figure 16.--The upper surface of a glued-laminated stringer after deck removal. Notice the short splits associated with many of the toenail holes and the larger checks associated with knots or slight defects along the centerline of the stringer. Such openings provide avenues for water entry and a resulting decay-hazard situation in the upper laminates of these stringers. (M 138 105)
